Aerial Photograph Review

Site History Report – October 2004

Ingersoll Rand Company Facility

Phillipsburg, New Jersey

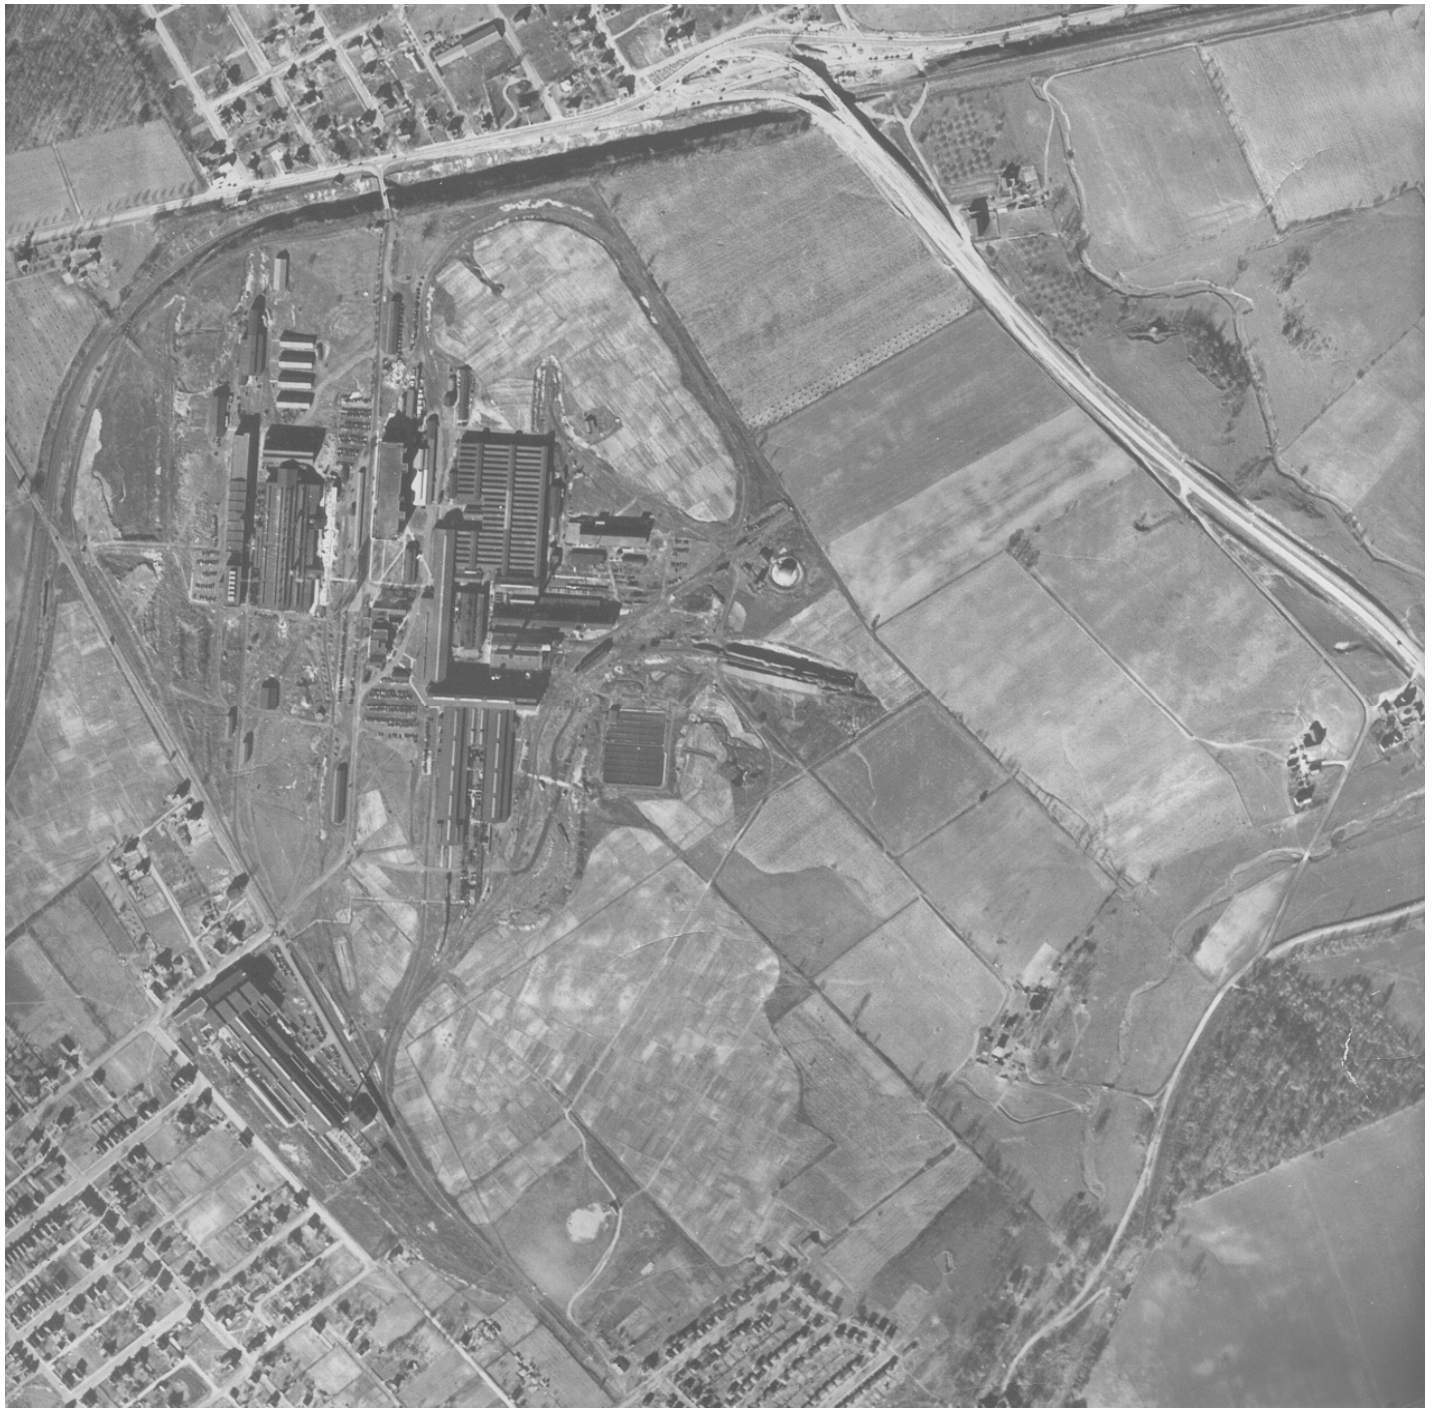
Source:
Aero Services 11/14/39

The November 14, 1939 aerial photograph (unknown scale) shows the Ingersoll-Rand facility (Site) and the adjacent Ingersoll-Rand farmland (farm). The site appears to be bordered on the north by railroad tracks and a major roadway (Route 22), a major road to the east (Route 22), open/agricultural land to the south and west, and some residential development to the southwest. There appears to be a stream (Lopatcong Creek) near the southern farm boundary. There are some residential neighborhoods north of the Site across Route 22. There is a small residential area east of the Site across the highway. Farther west, on the other side of the Site, there are extensive residential neighborhoods. Other than the Site itself, and these residential areas, the Site is in a rural area surrounded mostly by farmland to the north and east.

As shown in the photo, 52 buildings appear to be located on the site. However, the presence of shadows makes it difficult to identify exact building boundaries in some cases. In the southwest corner of the plant there appears to be a cluster of industrial buildings, identified in the historical review to be the Cameron Pump Division. To the northeast of Cameron Pump there is another cluster of industrial buildings. Based on the historical review the buildings further southwest are part of the Compressor division and the buildings further northeast are part of the Drill division. The building complex located the furthest northwest is the Foundry division. South of the Foundry division and west of the Compressor division there are four distinguishable buildings: one just south of the Foundry division, as well as two smaller buildings southwest of that building, and a longer building to its southeast. There are some soil/debris piles and possible small structures located east and northwest of the building closest to the Foundry division, as well as to the west of the other three buildings.

East of the compressor division there appears to be a reservoir (later identified as the Spray Pond). There appears to be two drainage streams off the eastern side of the reservoir. The southern most drainage stream disappears eastward quickly, the northern path drains into two or three ponds located to the east and is untraceable from there. The 1939 photo shows the presence of the Lopatcong Creek near the southern boundary and an apparent drainage ditch southwest of the southern group of farm structures. Based on facility records, discharge from the facility had been conducted through a subgrade pipe system that fed the concrete lined drainage ditch observed in the photograph.

Northeast of the Spray Pond is a long structure. Through existing reports and site investigations, the structure was identified as a coal trestle and appears to have railroad tracks leading into its western end.

Off the southeastern corner of the coal trestle northeast of the Spray Pond there appear to be several soil/debris or coal piles. Northeast of the coal trestle there appears to be a bulk storage tank, which was identified as an oil tank through the site investigation.

In the area south of the Spray Pond and southeast of the Compressor division there appear to be railroad tracks with soil/debris piles both sides. Through the site review, these piles were determined to be part of the land-filling activities conducted at the site (now identified as the Old Landfill).

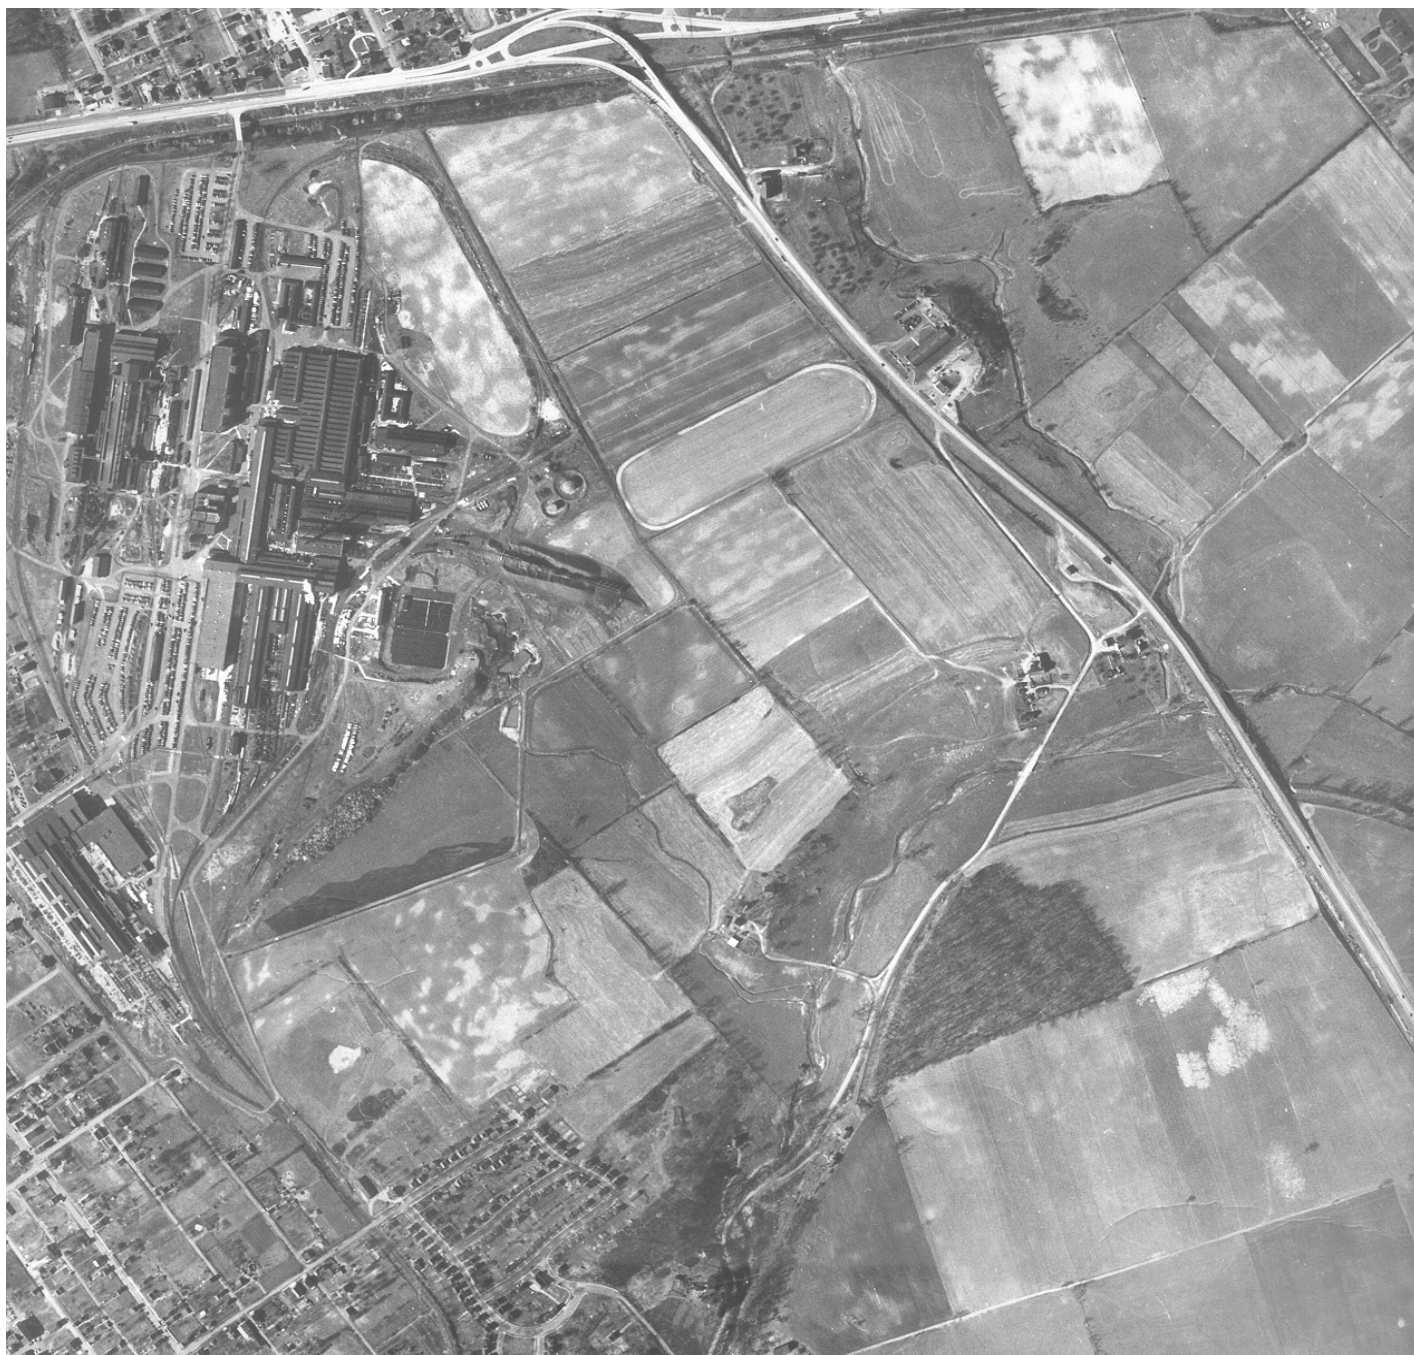
Source:
Aero Services 3/27/51

The March 23, 1951 aerial photograph (unknown scale) appears largely similar to the 1939 photograph with the following exceptions. The Site appears to have undergone some expansion. Many new structures, additions, and parking areas have been constructed across the Site. Outdoor storage areas appear to be located in and around the Cameron area, south of the Compressor division, southeast of the Spray Pond, as well as in and around the Drill division located in the northeast section of the site. A second bulk storage tank was constructed south of the previous oil tank. Two ponds appear to the east of the Spray Pond in line with an apparent drainage ditch. The coal trestle appears to be more defined than in the 1939 photograph. Filling activities at the Old Landfill appear to have extended southwest from the Spray Pond and drainage ponds into the southern portions of the site, which appeared cultivated in the 1939 photograph. There are soil/debris piles visible along the southern boundary of the Spray Pond as well. Areas slightly north of the filling activities and southwest of the Spray Pond appear to be used for storage. West of the foundry division in the northwest corner of the property four ponds have been added to the Site.

There also appears to have been a moderate increase in residential development in the area around the Site and farmland. A substantial area southwest of the reservoir midway to the Lopatcong Creek has developed since the 1939 photo.

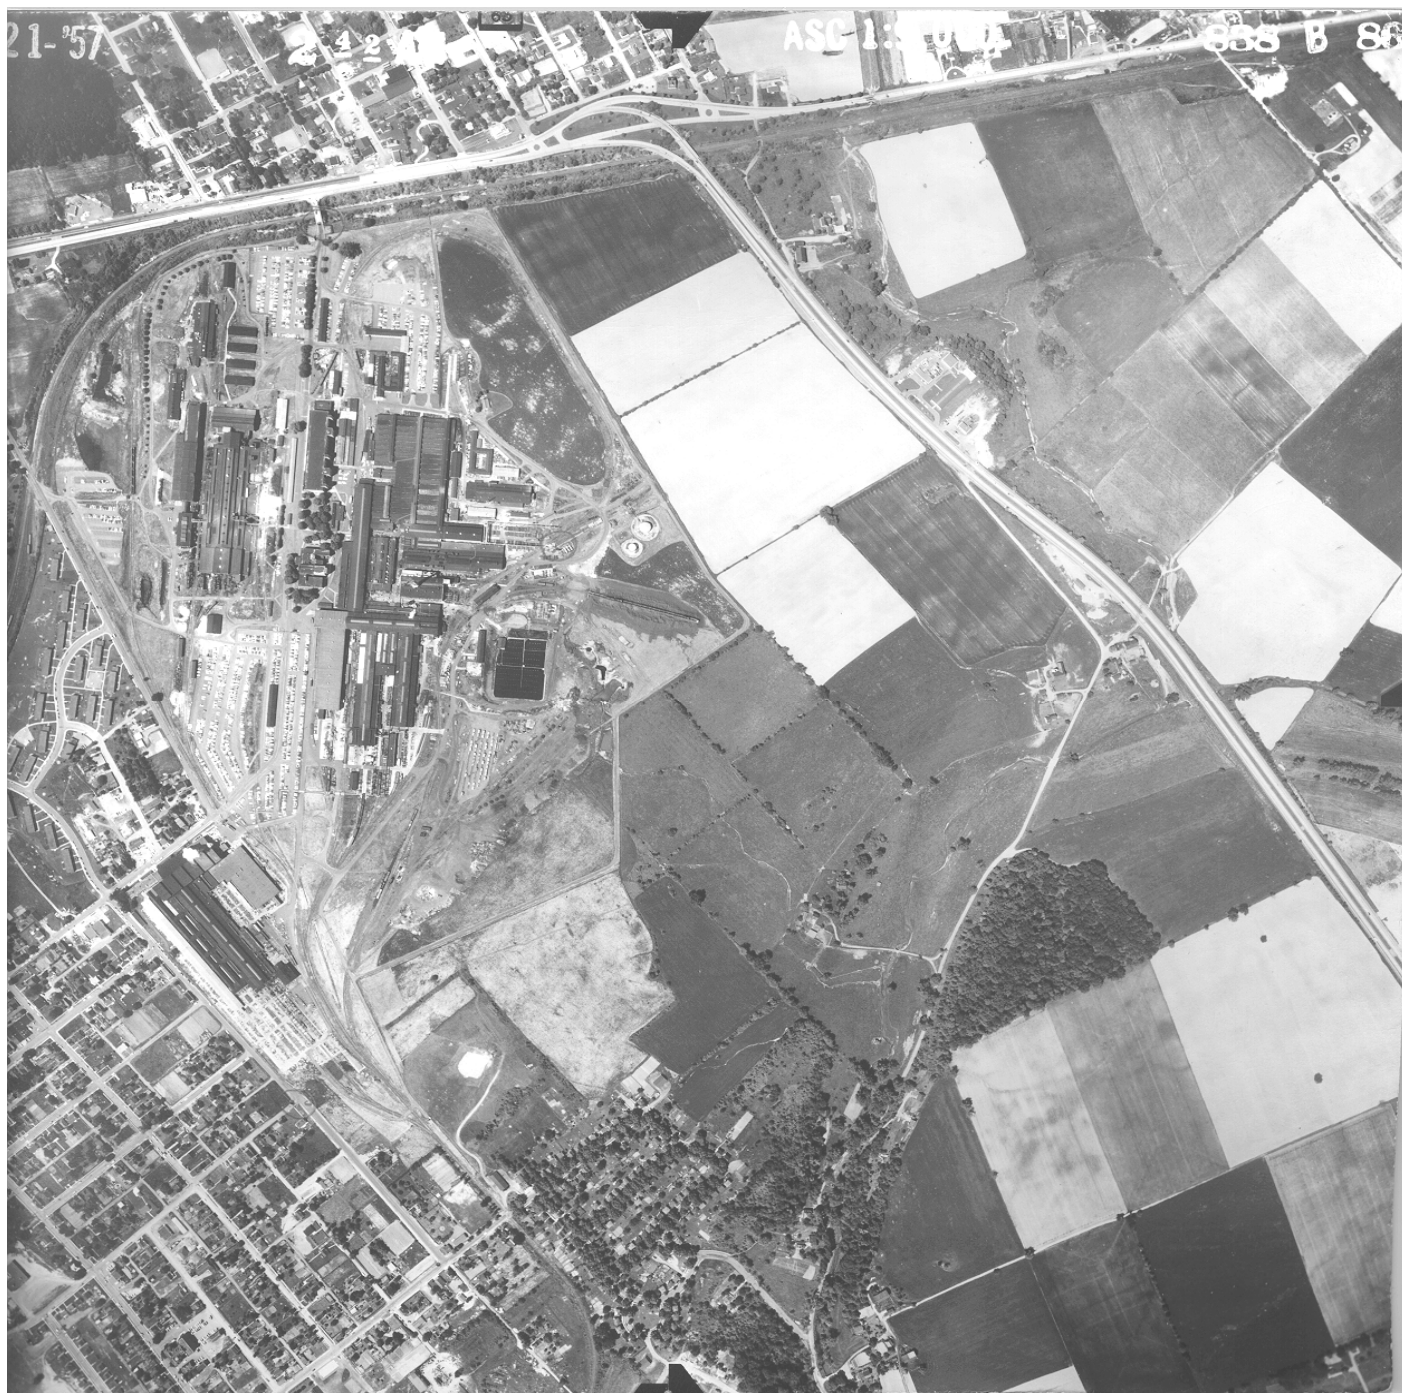
Source:
Aero Services 5/21/57

The Site, as observed in the May 21, 1957 aerial photograph (scale 1":750') appears similar to the 1951 photograph. The Site appears to have undergone some building alterations and construction. The fill activities to the south and west of the ponds and Spray Pond have increased from the previous photograph. The storage area south west of the Spray Pond has also increased from the previous aerial.

West of the Spray Pond and south of the Compressor division, four structures have been erected near the railroad tracks in the fill area. There appears to be two structures located east of the ponds and

west of the coal trestle. Northeast of the Drill division in the northeast corner of the Site there appears to be a storage area east of the parking lot and a debris area east of that. Outdoor storage has increased to the south of the Cameron area and what appears to be fill, is present in the southwest corner of the Site.

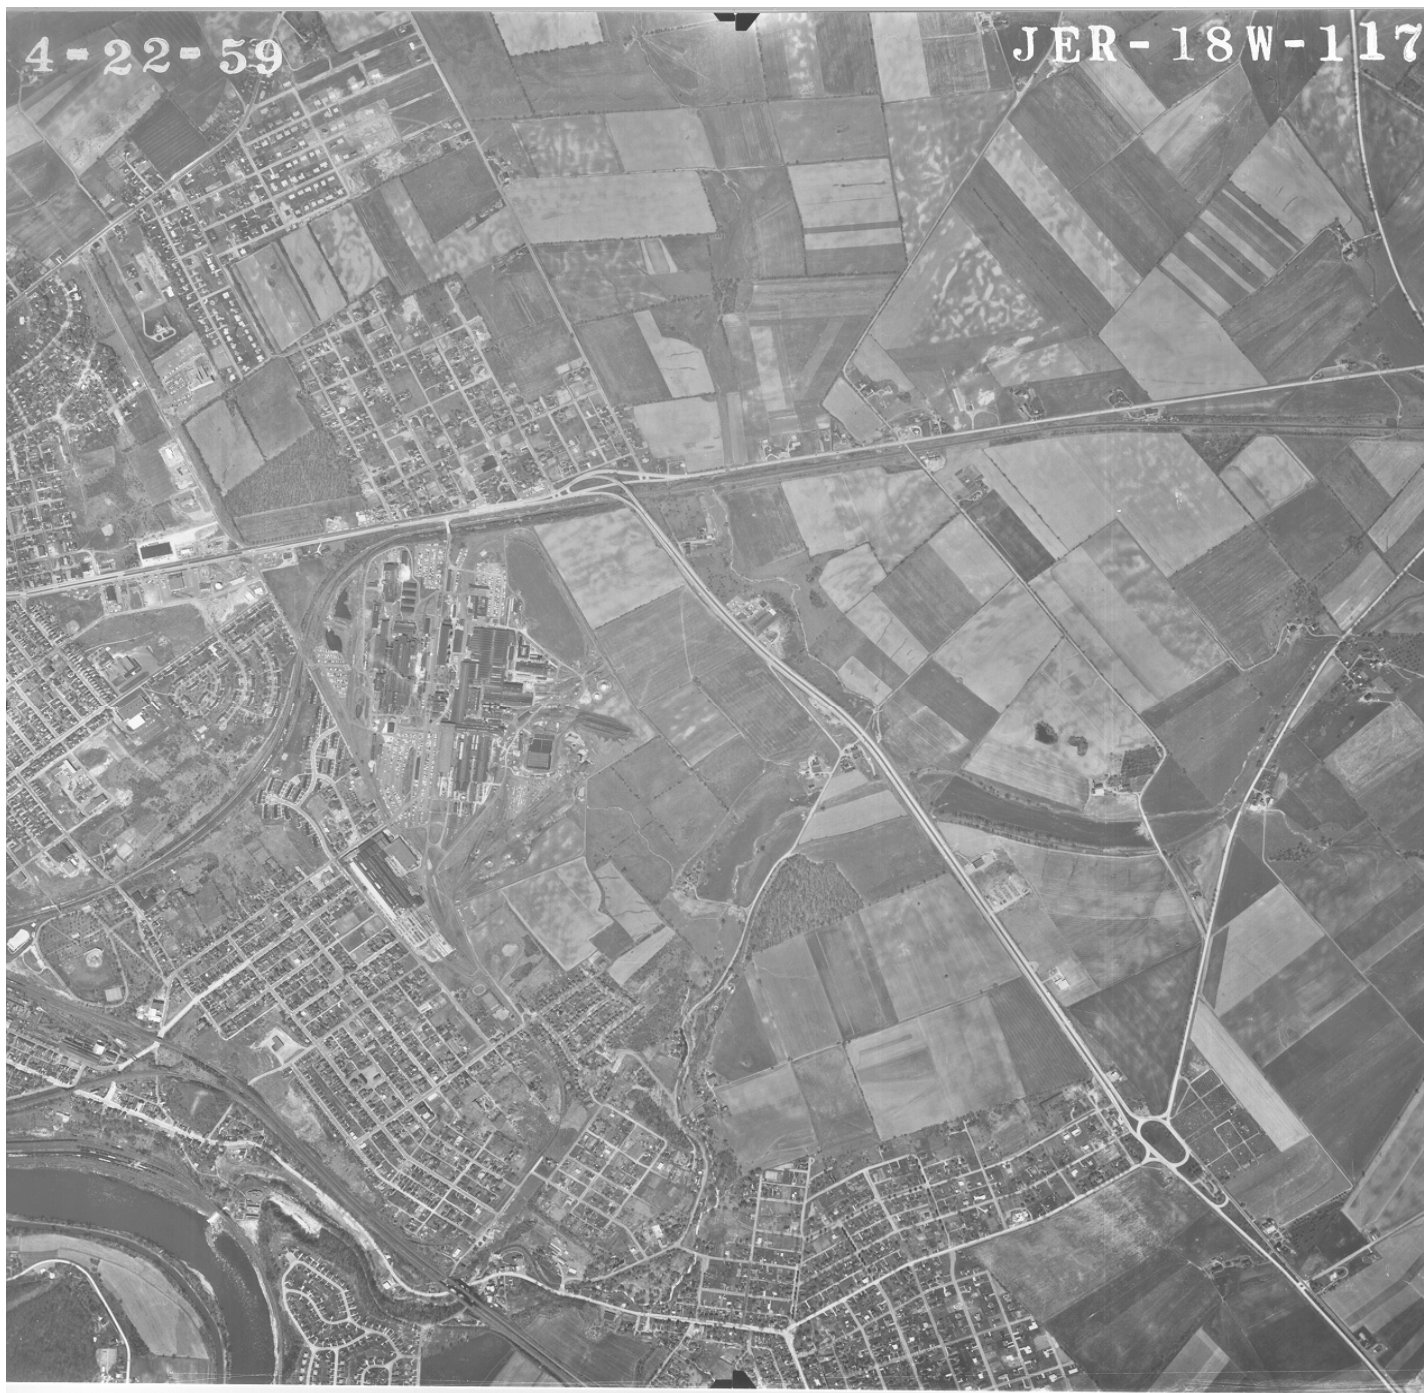
Source:
Robinson Aerial 4/22/59

The April 22, 1959 photograph (scale 1"=1500') does not appear to be different from the 1957 photograph except that additional area surrounding the Site is shown. No apparent changes are noticeable around the Site or the farm from the previous photo.

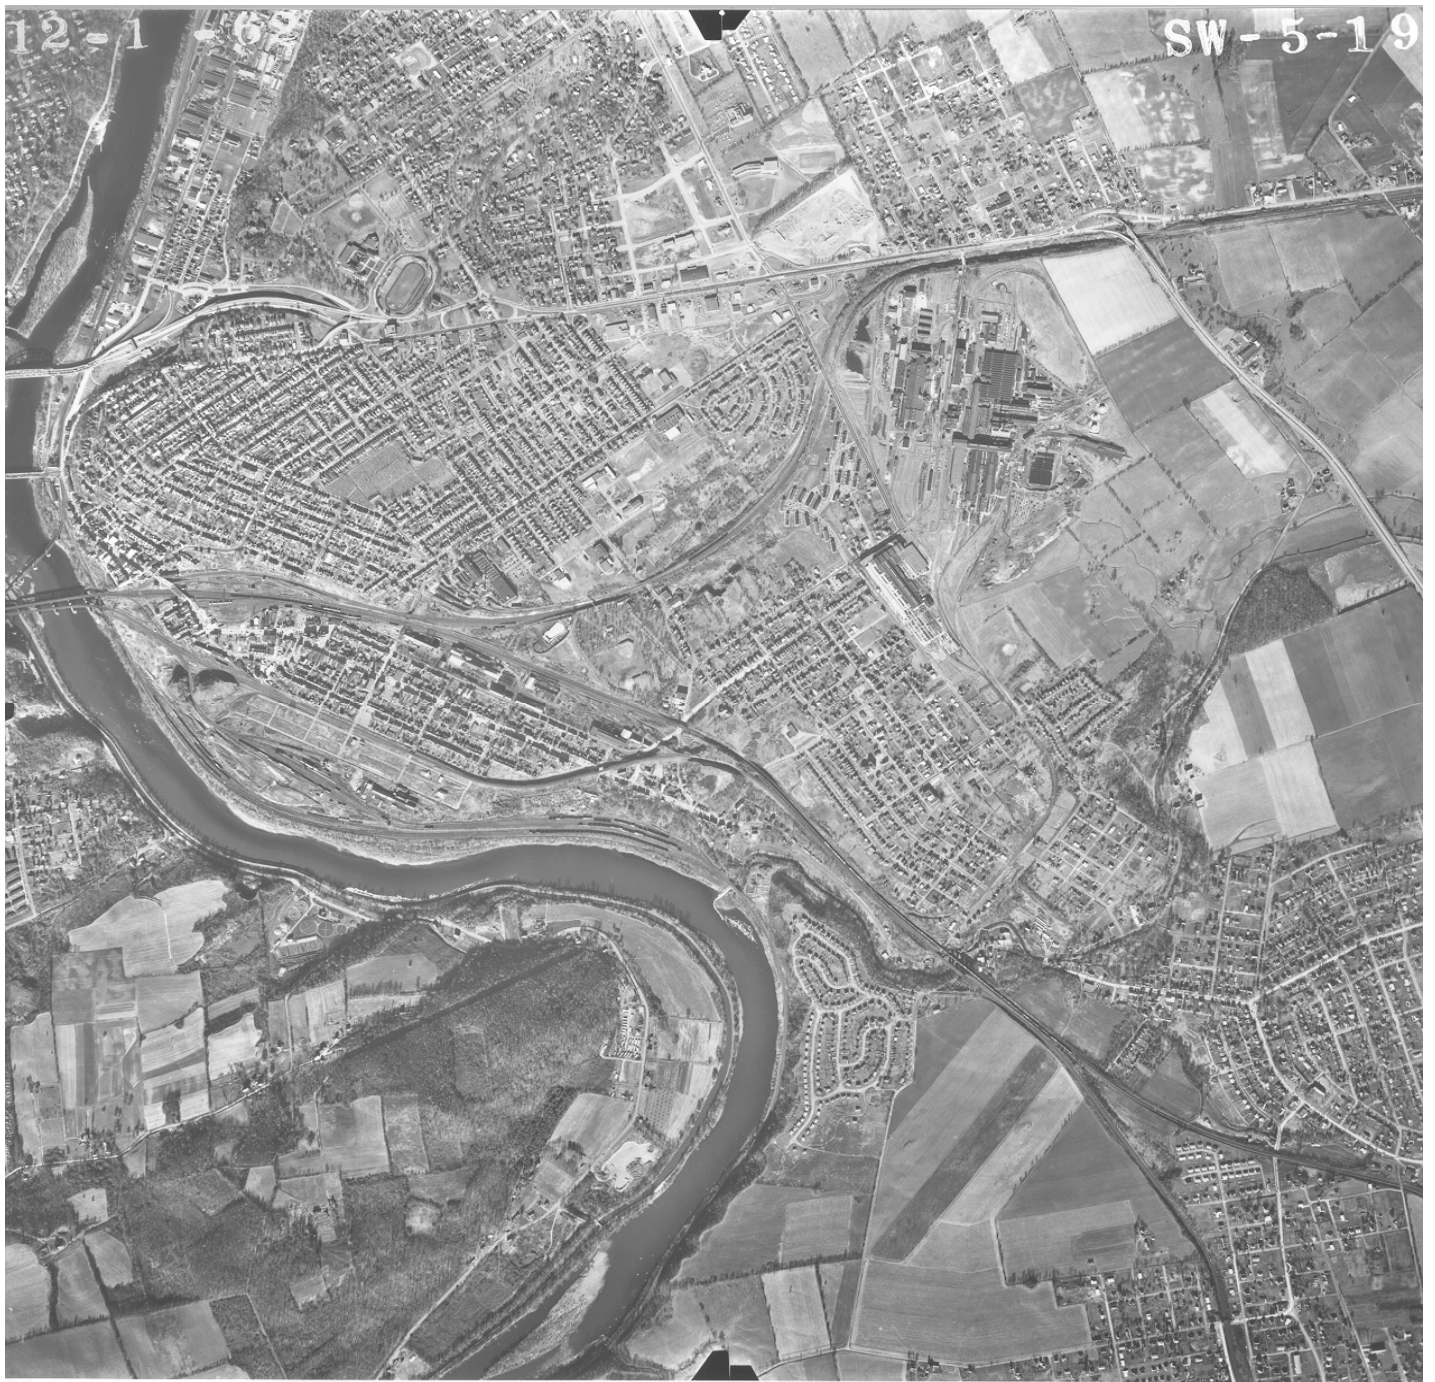
Source:
Robinson Aerials 12/1/62

The December 1, 1962 aerial photograph (scale 1"=1600') appears at a smaller scale than previous photos making smaller Site features more difficult to discern. On the Site, three bulk-storage tanks are visible northeast of the Spray Pond.

The third tank was constructed to the west of the previous two tanks. The Cameron division in the southwestern corner of the Site appears to have undergone some reconstruction and the outdoor storage area has increased in size. The two southern most ponds in the northwest corner of the site appear smaller than in previous photos.

Outdoor storage has increased around the Foundry division buildings in the northwest corner of the site. An anomaly (possibly a sink hole) has appeared in the northeast corner of the site north of the Drill division. The storage area southwest of the Spray Pond has increased from the previous years and filling activities at the Old Landfill continued from the ponds south of the Spray Pond west towards the Cameron division. There are more structures in the fill area on the south boundary of the Site. North east of the Drill division the storage area has increased from previous years.

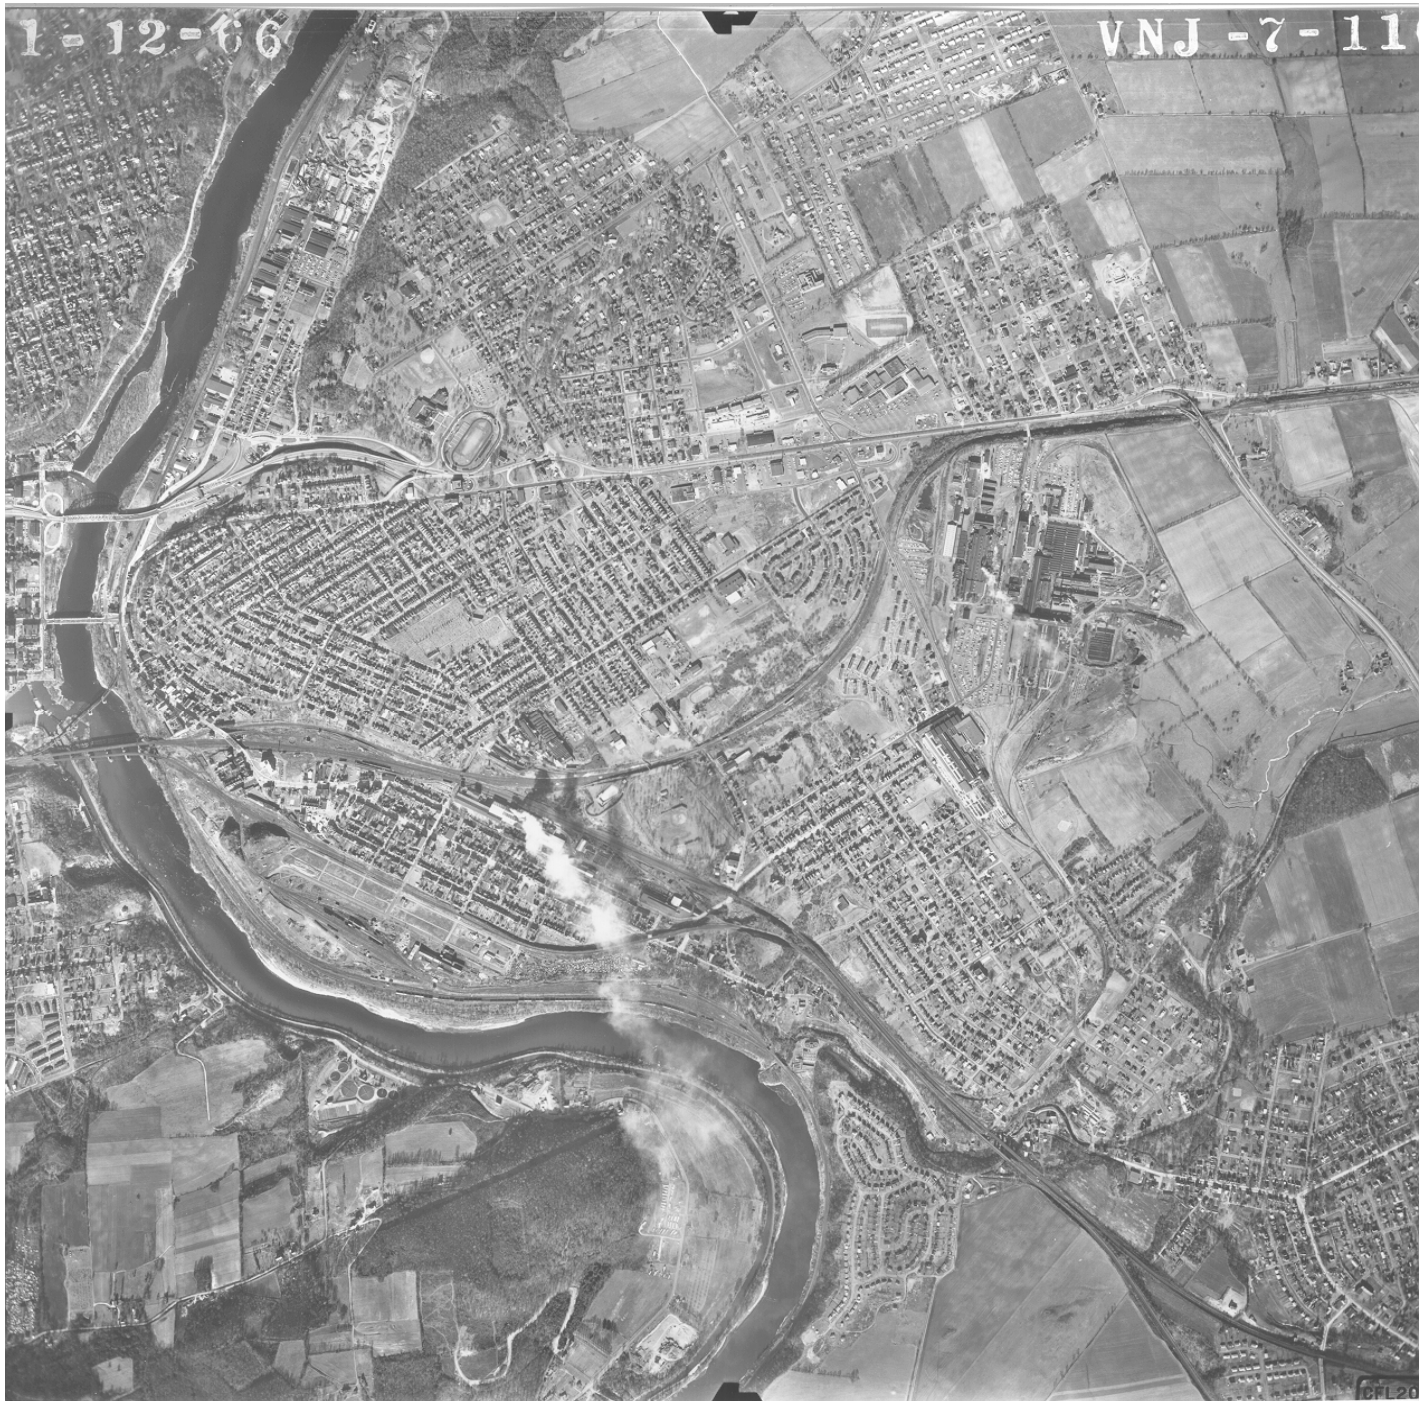
Source:
Robinson Aerial 1/12/66

The January 12, 1966 aerial photograph (scale 1"=1700') in general shows the site and surrounding area as they were in 1962. There appears to have been construction and reconstruction across the Site. The ponds west of the Foundry division appear less discernable. The buildings south of the Foundry division and west of the main parking area appear to have an increased outdoor storage area to the south. The filling process at the Old Landfill continues along the southern boundary of the Site. Soil/debris piles have increased in the outdoor storage area north of the Drill division east of the parking lot. The anomaly previously identified in the northeast corner of the site north of the Drill division is not discernable in the present photograph. Outdoor storage activities appear to have increased in the area west of the Spray Pond.

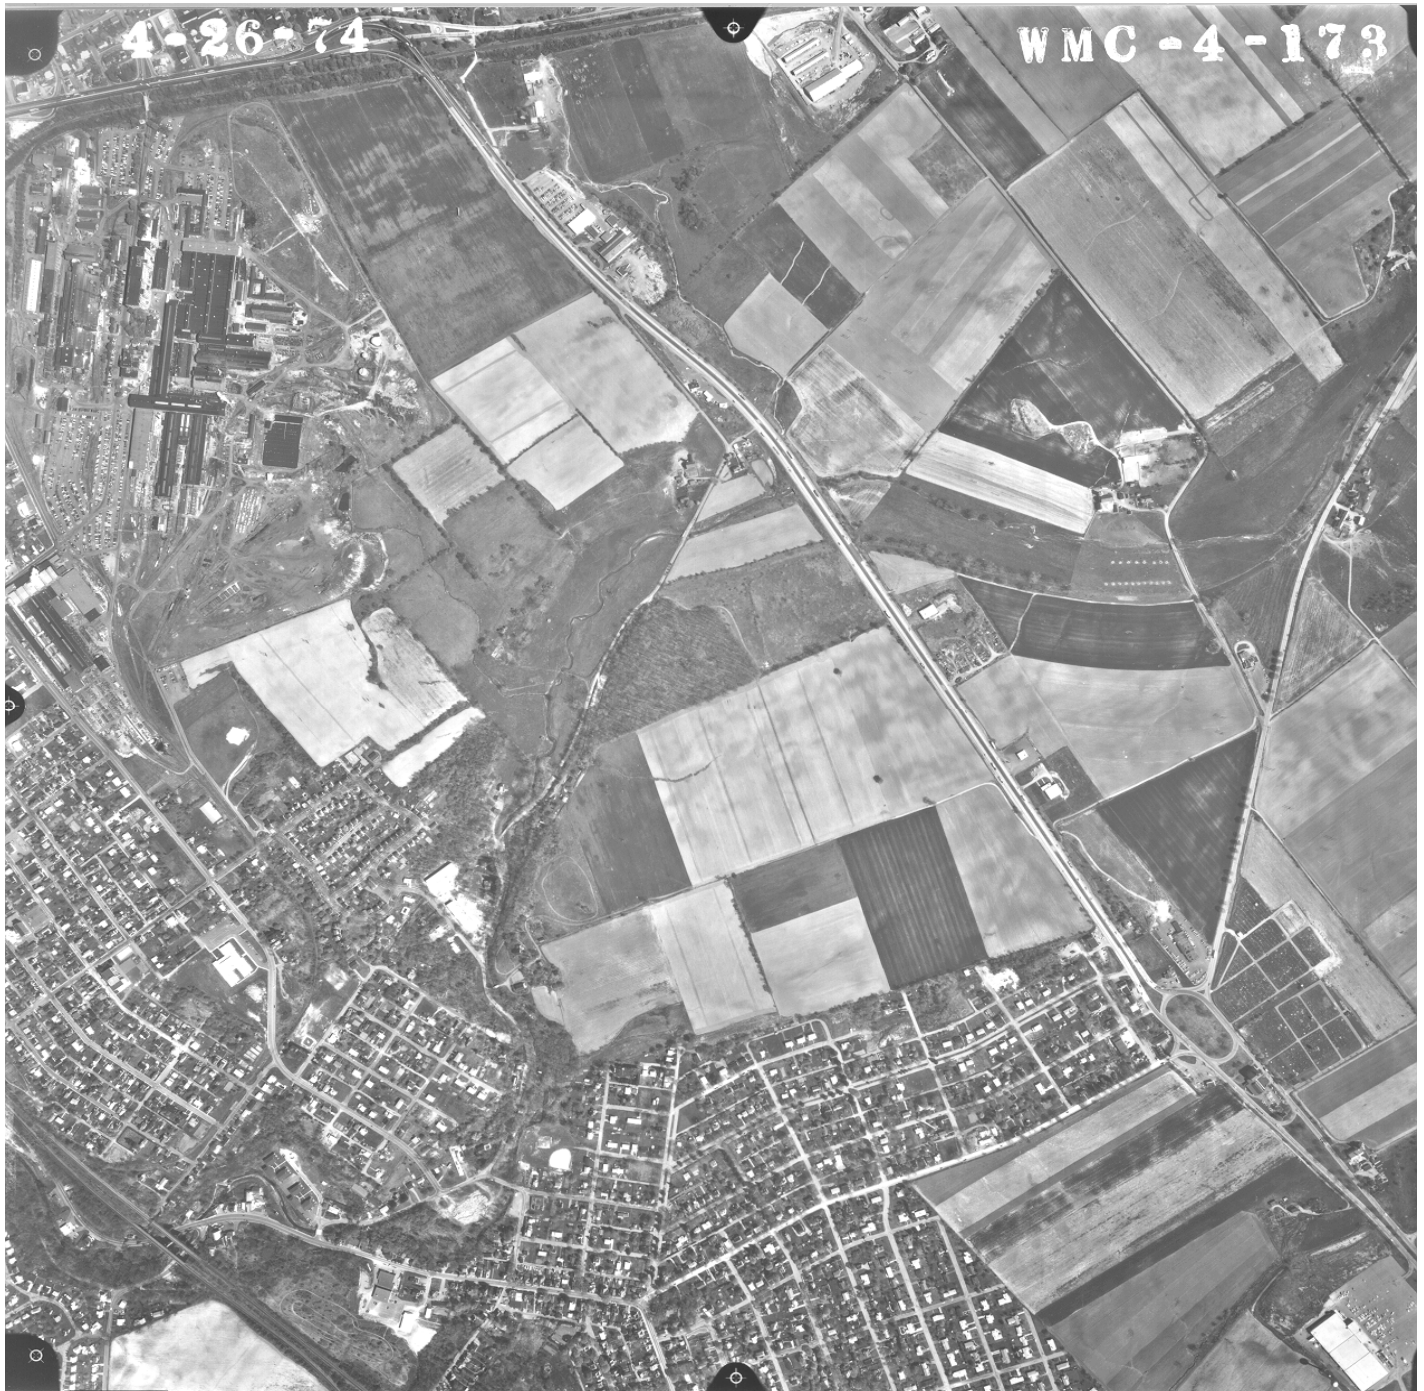
Source:
Robinson Aerial 4/26/74

The Site, as shown on the 1974 aerial photograph (scale 1"=1000') is largely similar to the Site configuration shown in previous years. Construction and reconstruction of the structures at the Site vary from the configuration in the 1960s. Filling operations at the Old Landfill appear to have continued to the southeast beyond the western pond, south of the Spray Pond and have reached the farm boundary. There appears to be nine rectangular structures in a line approximately 20 feet by 40 feet southwest of the Spray Pond in the fill area. Also, the coal trestle on the east side of the facility (south of the bulk storage tanks) appears to have been removed. The railroad tracks are still visible, however, immediately south of the area where that coal trestle was located, and some dark piles appear to remain. Immediately to the northeast of the bulk storage tank farm there appears to be the foundation for another tank, though no tank is visible. The area east of the tracks and south of the bulk storage tanks appears to have soil/debris piles (previous photographs show an uncultivated area). Soil/debris piles are also discernable north of the bulk storage tanks at the boundary of the farm. The storage area north of the Drill division has increased soil/debris piles toward the east. Directly east of the there at the farm boundary appears to be a new outdoor storage area in a section of the property previously undisturbed. In the bulk storage area there appears to be a new storage tank foundation northwest of the existing bulk storage tanks. Outdoor storage has increased in and around the Drill division and Compressor division building complex. Two of the four ponds west of the Foundry division are less discernable than previous years.

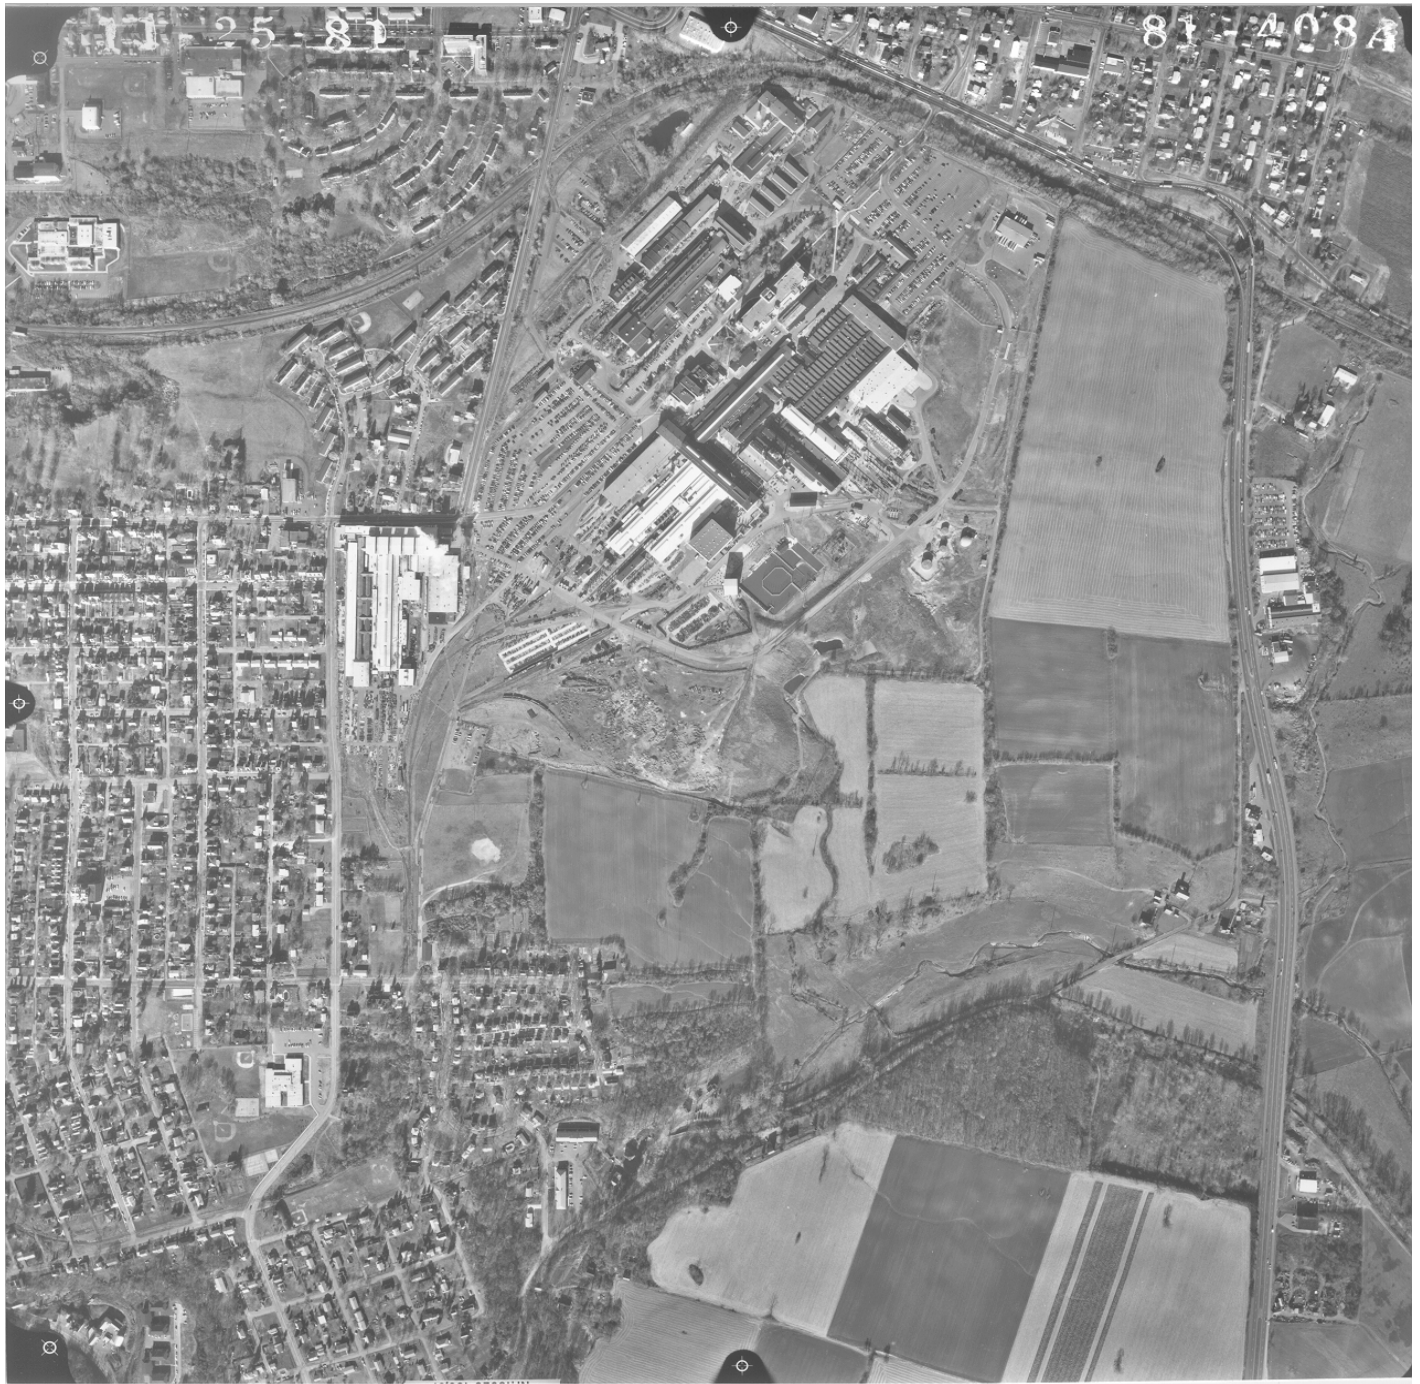
Source:
Robinson Aerial 11/25/81

The November 25, 1981 aerial photograph (scale 1"=750') shows the Site in similar configuration to the previous photo without any discernable differences. The Site appears to have undergone some construction across the facility as well as in the northeast portion of the Site, where a new building and parking areas appear. A new bulk storage tank is apparent in the tank farm where the foundation was observed in the previous photograph. The tracks from the coal trestle have been removed with only soil/debris piles remaining in the area. There appears to be a roadway along the southern and eastern sides of the facility identified through a site review as Loop Road. The fill has leveled around the ponds and the Spray Pond toward the west. The fill activities continue further west than previously noted and up to the farm boundary in the east. The area off the southwest corner of the Spray Pond has become a building and large storage pad; there are no more visible soil/debris piles in the area.

There is a new storage area visible south of the Compressor division roughly 150 feet by 350 feet. Outdoor storage and parking lots have been altered across the Site from the 1970's photograph. There is only one discernable pond remaining west of the Foundry division. The storage/debris area located northeast of the Drill division appears to have been leveled and used primarily for storage at this time. The previous storage area directly east of there has also been leveled and is merely a roadway (part of Loop Road) and a field. A few railroad tracks appear to remain on Site.

No other significant changes from the previous photo are noticeable in nearby areas.

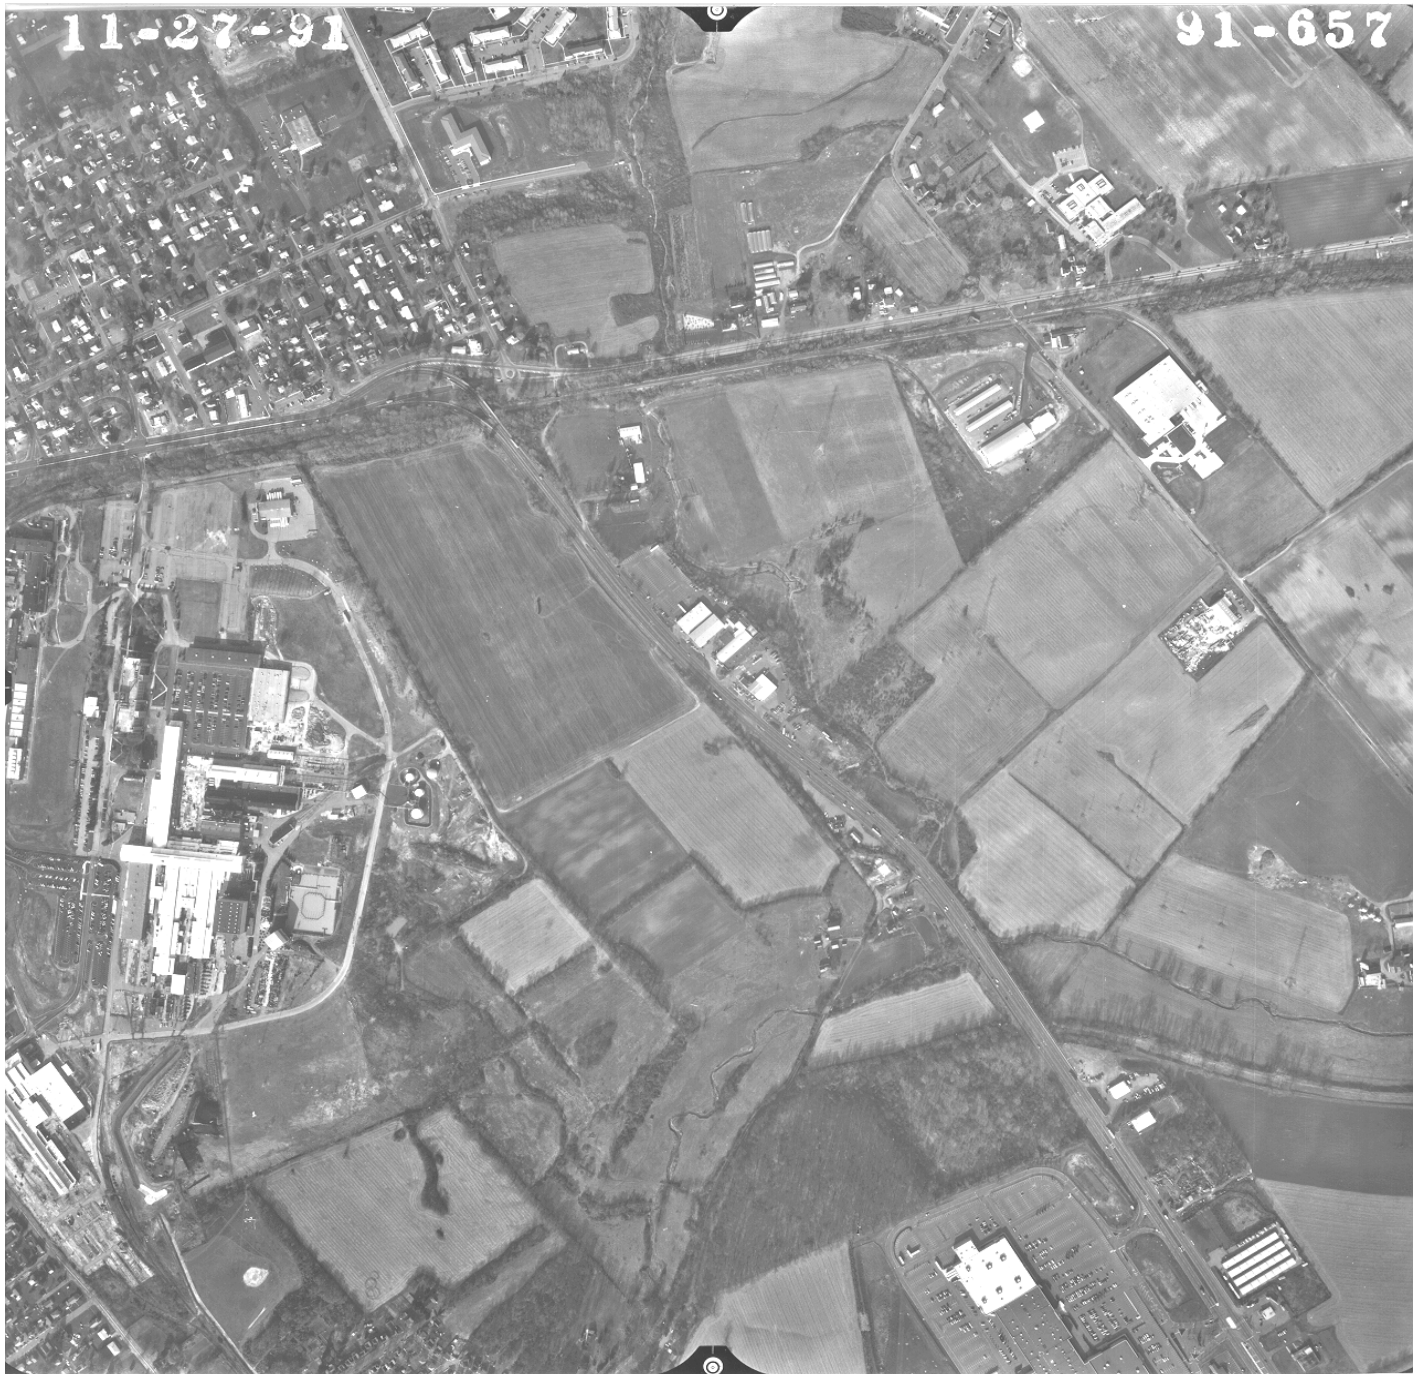
Source:
Robinson Aerial 11/27/91

The November 27, 1991 aerial photograph (scale 1"=800') does indicate significant changes at the Site. The Site appears to have undergone several building removals throughout the facility, specifically in the Foundry division along the north and central portions of the main facility area, the Drill division in the eastern portion of the facility, and the Cameron division in the southwestern portion of the facility. West of the Foundry division the previous ponds are not discernable, but there is a new pond in the area. East of the Drill division and west of the bulk storage tanks there appears to be a diverse soil/debris pile. In the area of the previous coal trestle it is unclear whether the area is covered by debris or vegetation. Additionally, areas south of the new Loop Road appear substantially different. The large storage area south of the Compressor division has been removed. Facility records indicate that the New Landfill was constructed during this period and appears toward the southwestern corner of the facility; and the Old Landfill was covered during this time. Northeast of the Cameron division there appears to be some soil/debris piles. There are no more discernable railroad tracks remaining on Site.

The nearby farm does not appear to have significant changes with the exception that the silo formerly present at the former Pursel Farm house appears to have been removed.
